Surveying Wood Hulls

by [David Pascoe](#)

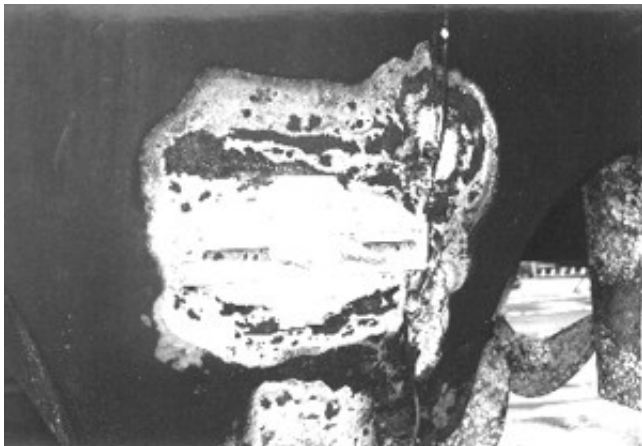
The effects of stray current are usually unmistakable. This is the remnant of a zinc anode attached to a bonding system that was subjected to a full twelve volts, leaving an obvious burn pattern. The zinc did its job and

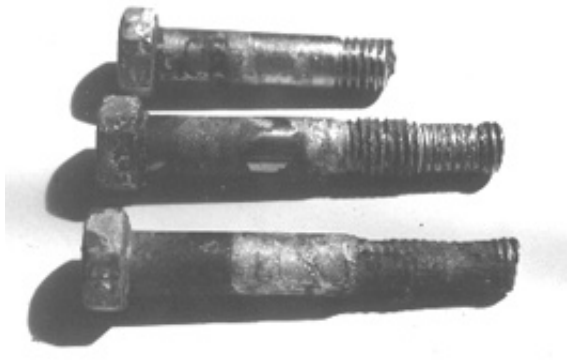
Corrosion of stainless bolts by crevice corrosion or acid attack. The prominent feature is that the active corrosion

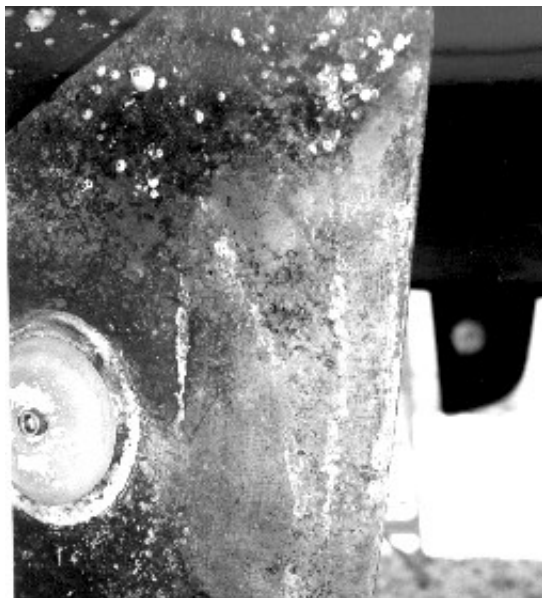
This is erosion corrosion on a rudder blade caused

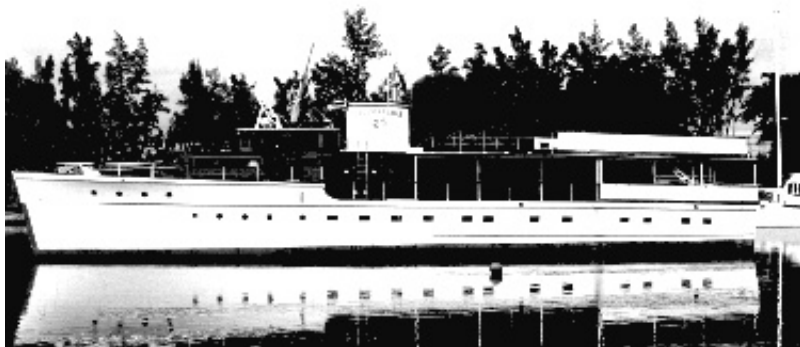
Hogging, a condition in which a hull is actually sagging with age, is an accurate indicator that a wood hull has reached the point of severe structural degradation and can no longer be considered safe. This condition is plainly
